AFRL-ML-WP-TR-1998-4127

ENHANCED LASER GENERATED ULTRASOUND

**BOEING INFORMATION, SPACE & DEFENSE SYSTEMS
P.O. BOX 3999
SEATTLE, WA 98124**

FINAL REPORT FOR DECEMBER 1996 THROUGH FEBRUARY 1998

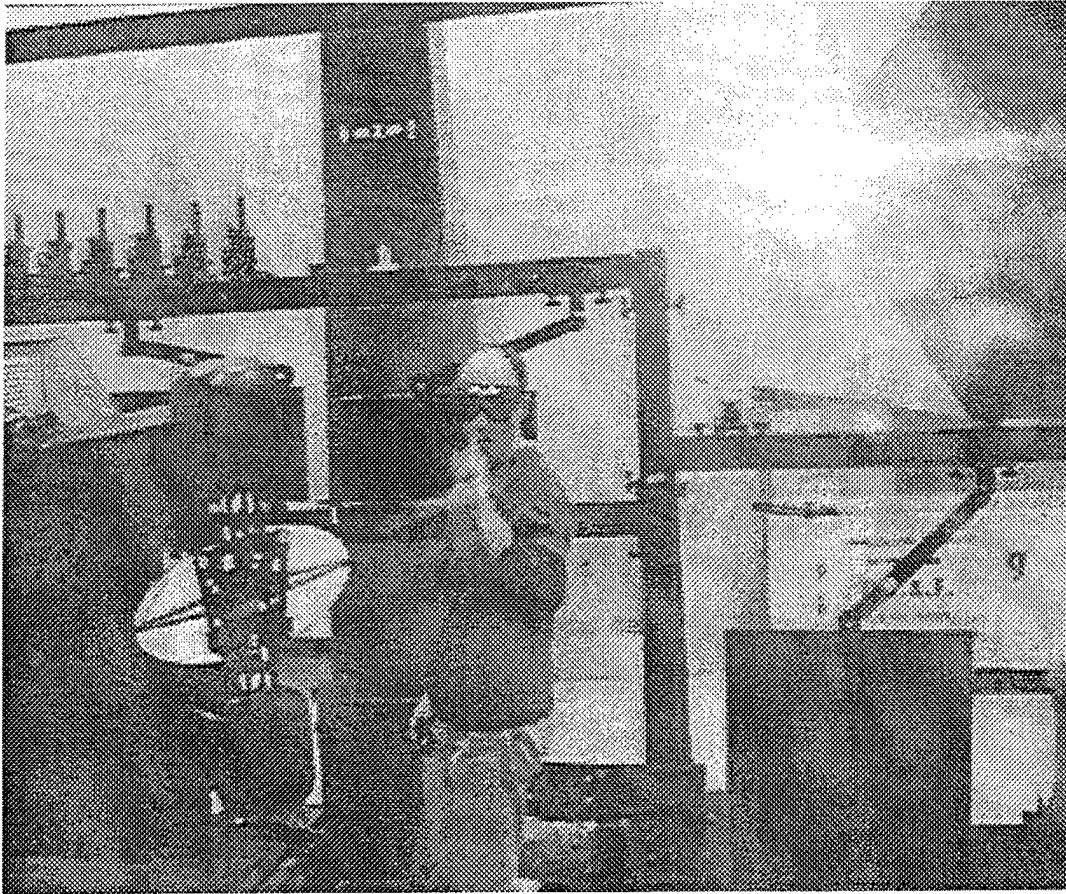
To determine the laser damage threshold, an operator must be inside the inspection bay in order to closely watch the part's surface. The damage threshold assessment is presently impeded by the inability of the operator inside the inspection bay to control the firing of the LUIS lasers. A second operator in the control room must fire the laser while the first operator looks for any laser damage from inside the inspection bay. Figure 3-2 shows a technician inside the inspection bay provide feedback on test firing of the laser.

Figure 3-2. Technician Communicating Laser Power Setting Information to Control Room

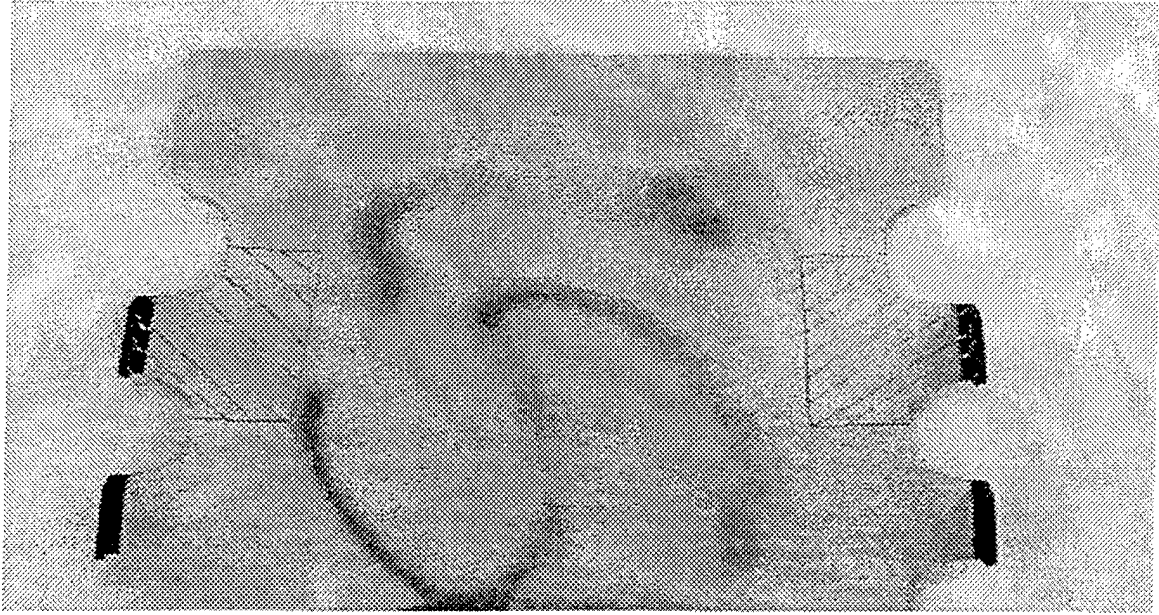
Figure 5.1.5-1. Photograph of 777 graphite composite rib with foreign materials

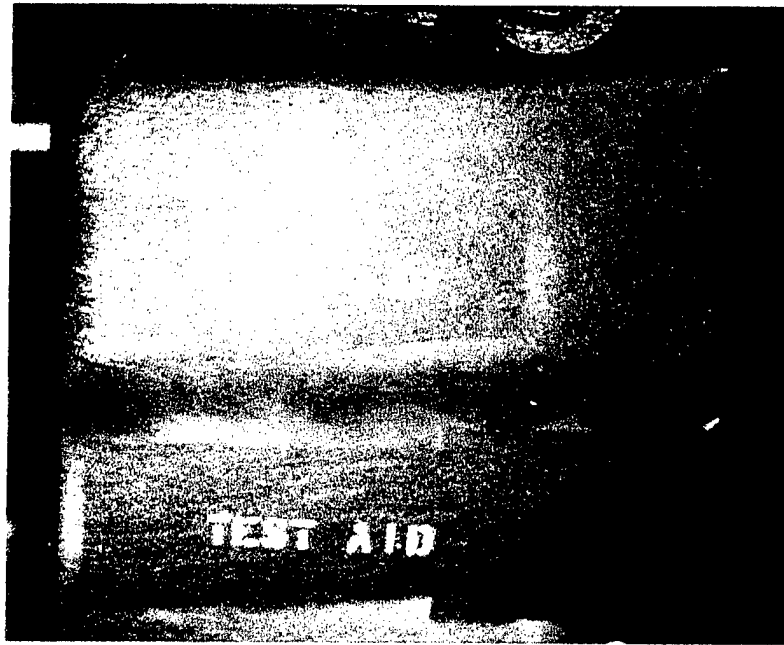
This standard was used to establish NDE sensitivity for scanning associated with the A-6 re-wing program. The part is shown in Figure 5.2.1-1. It consists of two levels of composite, one 41 plies thick, and the other 83 plies. The transition area between the two levels has two rows of five 0.5" by 0.5" inserts made from five different materials. The inserts are located a number of plies from each of the sides of the panel, with one row being parallel to the flat tool side, and the other parallel to the slanted transition area on the bag side. It is normally reasonably difficult to detect the inserts that are not parallel to the surface from which the scan is taken.

Figure 5.2.1-1. A-6 Ply Drop Standard

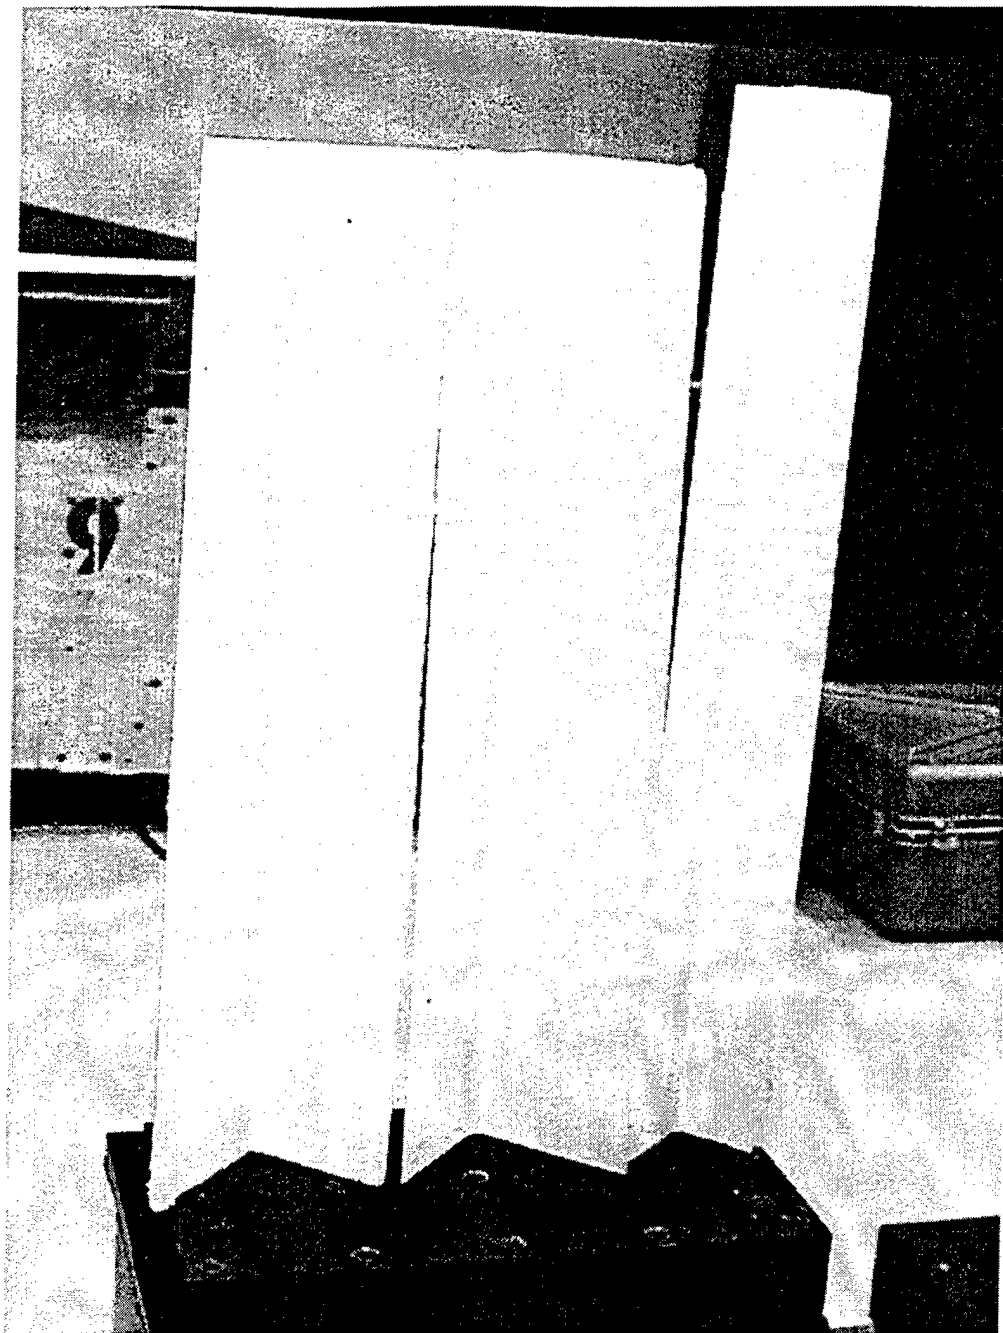
Figure 5.2.5-1. Photograph of F-22 angle standards

These standards are ninety-degree angles with three different bending radii, one at 0.13", one at 0.25", and the last at 0.38". Each of the standards has several thickness regions, resulting from differing numbers of plies in the regions. There are 0.25" x 0.25" and 0.5" x 0.5" inserts along the vertices of the standards at varying depths. The three standards are shown placed in position for scanning with the LUIS in the photograph in figure 5.2.5-1. In each case, the thickest region of the standard is at the bottom. The view is towards the interior angles of the standards. The standards have been painted white for better UT generation into the composite material.

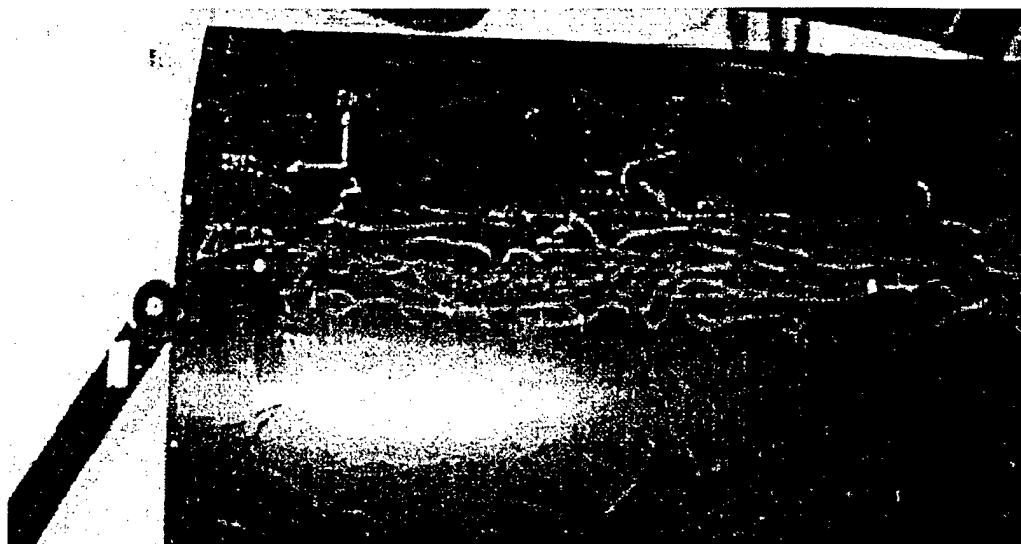
Figure 5.2.8-1. B-2 Wing panel tool-side.

These panels are NDE standard flaw panels for the B-2 program. They are curved leading edge panels with stiffeners. The stiffeners are placed as "U" sections on the inner surface of the curved panels, and a second cure process bonds them to the curved panel. This process results in each of the stiffeners being assembled from the vertical portions of two adjacent "U" sections, with the horizontal portions in contact with the inner surface of the panels. A photograph of the toolside such a panel is shown in Figure 5.2.8-1. Figure 5.2.8-2 shows the stiffeners on the bagside of the panel. There are a number of 0.25"x 0.25" and 0.5"x0.5" teflon inserts. These occur both under the stiffeners, as well as across the joint between the curved panel surface and the space between the adjacent "U" sections.

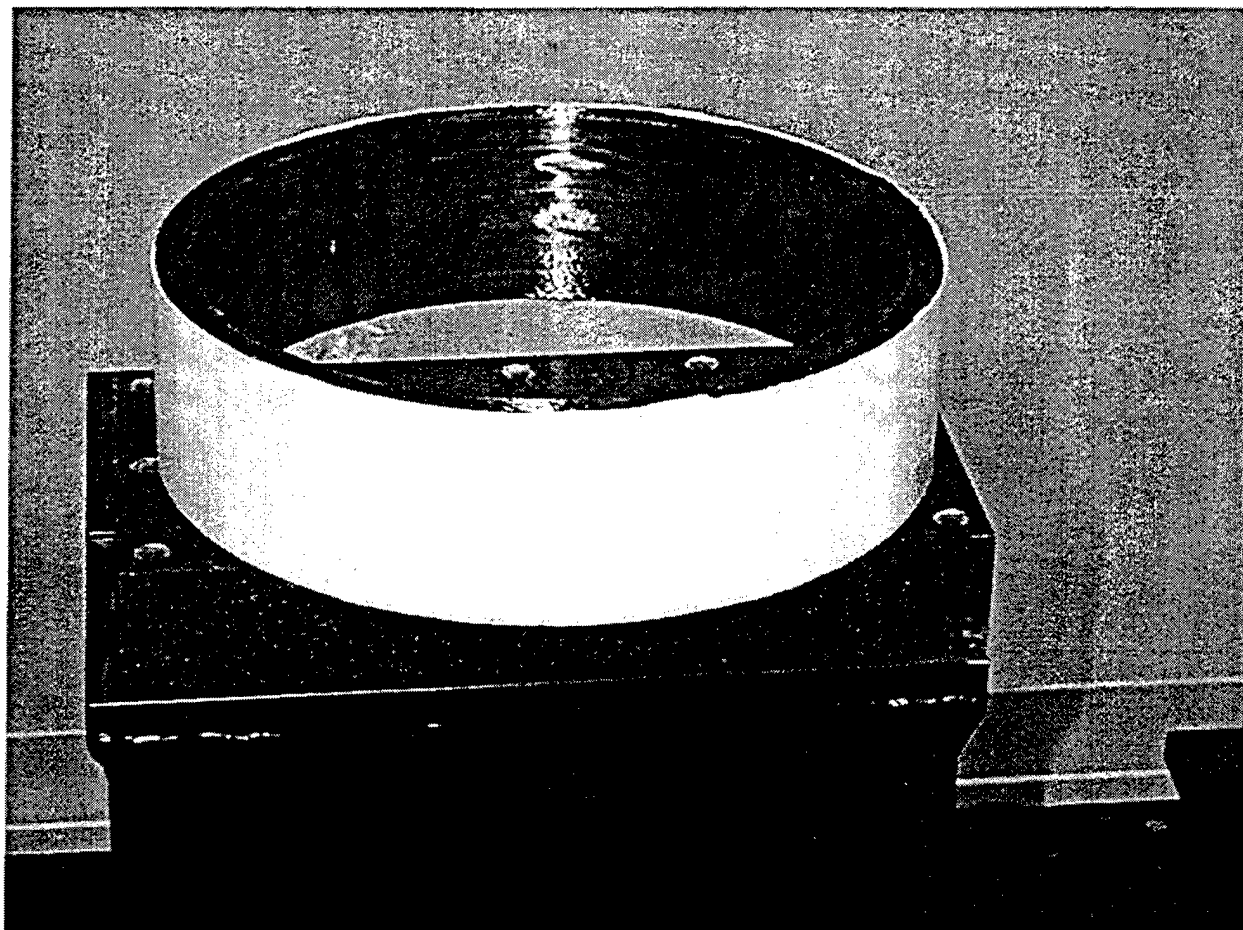
Figure 5.2.16-1 Composite Flywheel

This part was constructed for purposes of storing energy on spacecraft. It is an annular ring approximately 16 inches in diameter, 5 inches in length, and $\frac{3}{4}$ inch thick. It is made up like a roll of tape as one continuous piece of prepreg material, which is cured as it is rolled. This particular specimen showed several regions of delamination when inspected by computed tomography. A photograph of the flywheel positioned for scanning with the LUIS flywheel is shown in Figure 5.2.16-1.

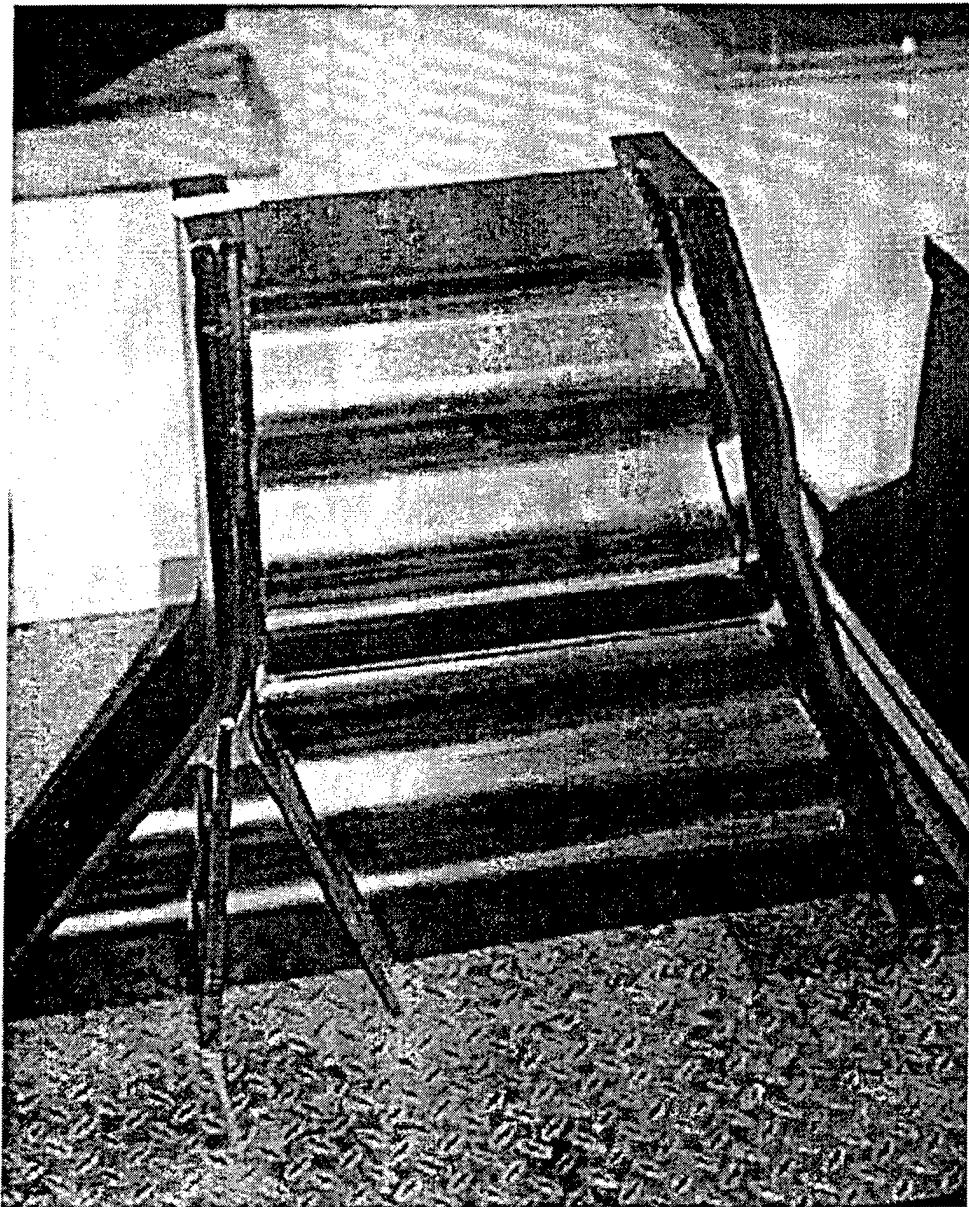
Figure 5.2.19-1. A section of a larger prototype structure for the F-22 program

This highly unique part is shown in Figure 5.2.19-1. It is a section of a larger prototype structure for the F-22 program. A quick glance shows the complication of scanning such a part with any sort of device. Only a non-contact method such as Laser UT has a chance of scanning the whole part. There are widely varying thicknesses, two different thicknesses of sine wave webbing, various angles, complex bond lines, and at least two tight vertices of about 30 degrees.

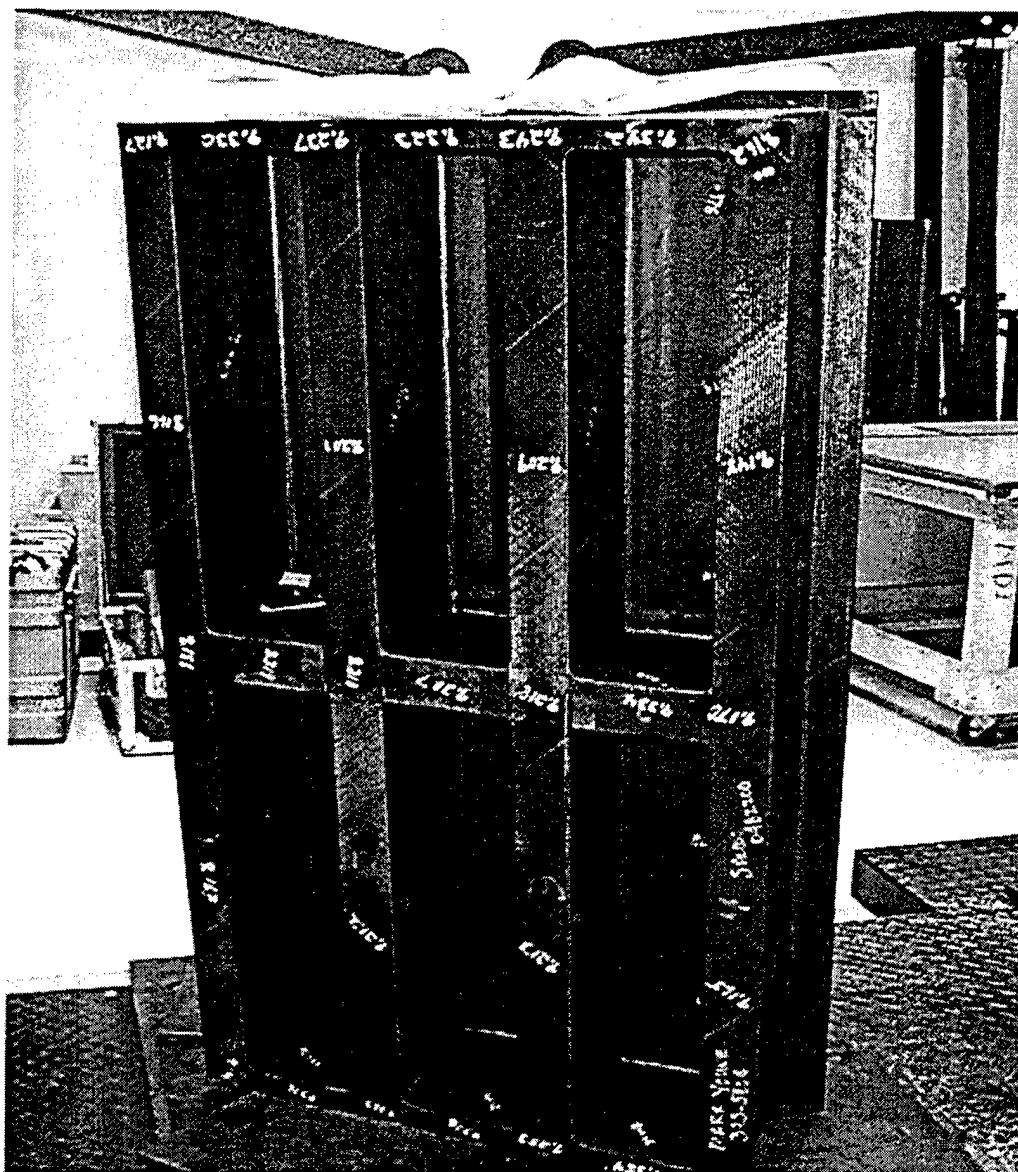
Figure 5.2.20-1. Integral wing box prototype

Current trends are towards making larger and larger composite portions of airframes. The prototype one piece wing box pictured in figure 5.2.20-1 is a good example demonstrating this trend. The entire part is cured as one piece. This of course causes more dependence on quick and comprehensive NDE. It is easy to see the large number of scans required of a hand held or robotically controlled scanner. There are 48 interior three-dimensional corners, 48 interior right angle intersection lines, 11 panels, and the back surface that would need to be inspected.

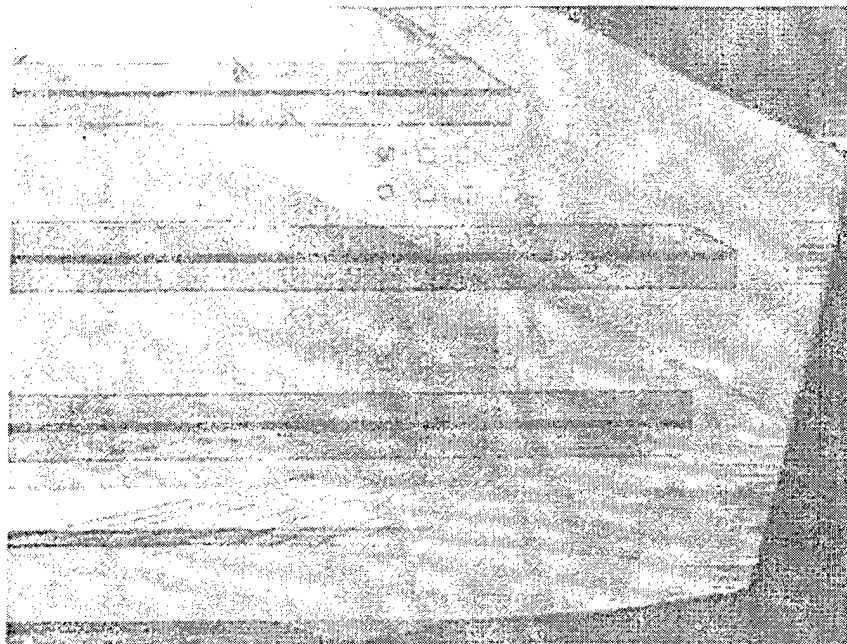
Figure 6.3-5. Fifth scan

The second characteristic revealed by this study is the consistency between successive scans of the same part. The degree of consistency may be used as a measure of system repeatability. Amplitude C-scan images from the five scans are shown below as figures 6.3-1 through 6.3-5. Each of the images is taken from one of each of the five full wave data sets acquired with the

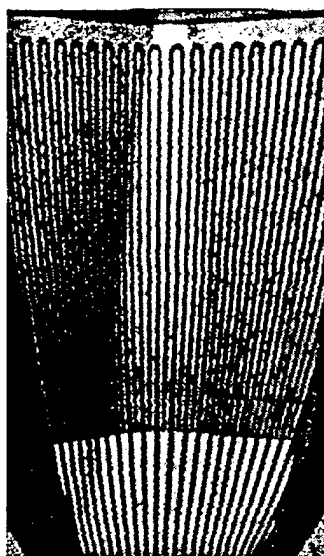
Figure 6.4-2. Rockwell Science Center LBU scan of rocket nozzle

As a comparison to the typical LUIS scan of this part, figure 6.4-2 shows a scan from another LBU system. The Rockwell Science Center has spent 10 years investigating the capabilities of LBU and has developed a very flexible, brassboard-type laboratory LBU system. The same rocket nozzle was scanned at this LBU laboratory. The nozzle was painted and inspected using a 10.6 μm CO₂ generation laser and a long pulse 1.064 μm Nd:YAG detection laser. The Rockwell Science Center LBU image resolution is 200 x 345 pixels and smaller laser spot size was used than on LUIS. This is somewhat greater resolution than available from the fixed resolution of the LUIS as is evident from comparing the images. This difference points out the desirability of designing LBU systems to allow easy changes in resolution and other system parameters. It is important to remember that LUIS parameters such as spot size were specified values and do not represent fundamental limitations on LBU technology.
